ANNUAL PROGRAM REVIEW

CORROSION CONTROL

March 8, 2000

**Institute of Paper Science and Technology
500, 10th Street, NW
Atlanta, GA 30318**

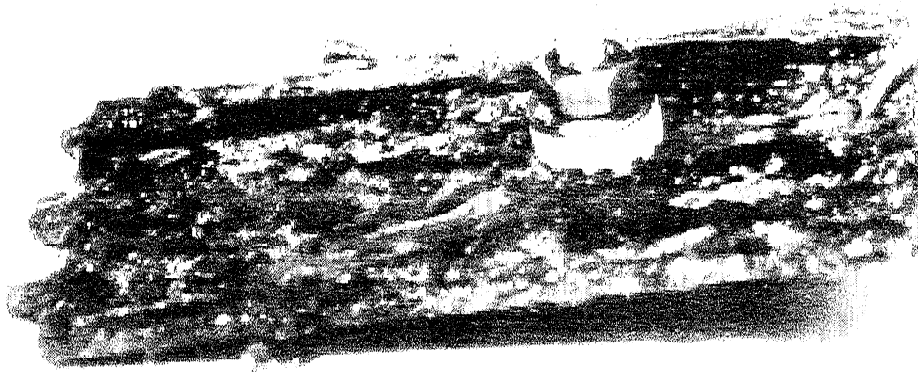
Figure 7. Carbon steel coupon after 90 days exposure to TAPPI-D mist

In these tests, samples were not allowed to intermittently dry and concentrations to built up on sample surface. These tests represent the areas of paper machine where metallic structures are exposed to the white-water mist continuously. These tests show that continuous white-water mist/fog environment is not corrosive to the stainless steels. Even 304L stainless steel samples did not show any signs of localized or general corrosion in up to six-month exposure. However, carbon steel samples showed active corrosion in this environment. Figure 7 shows the appearance of a carbon steel coupon after 90 days whereas Figure 8 shows a graph of the weight loss vs. time for carbon-steel for times up to 180 days. Corrosion of carbon steel increases with time. Corrosion scale on the carbon steel was loose and therefore does not seem to provide any barrier for corrosive environment to reach the metal surface. Therefore, carbon steel components

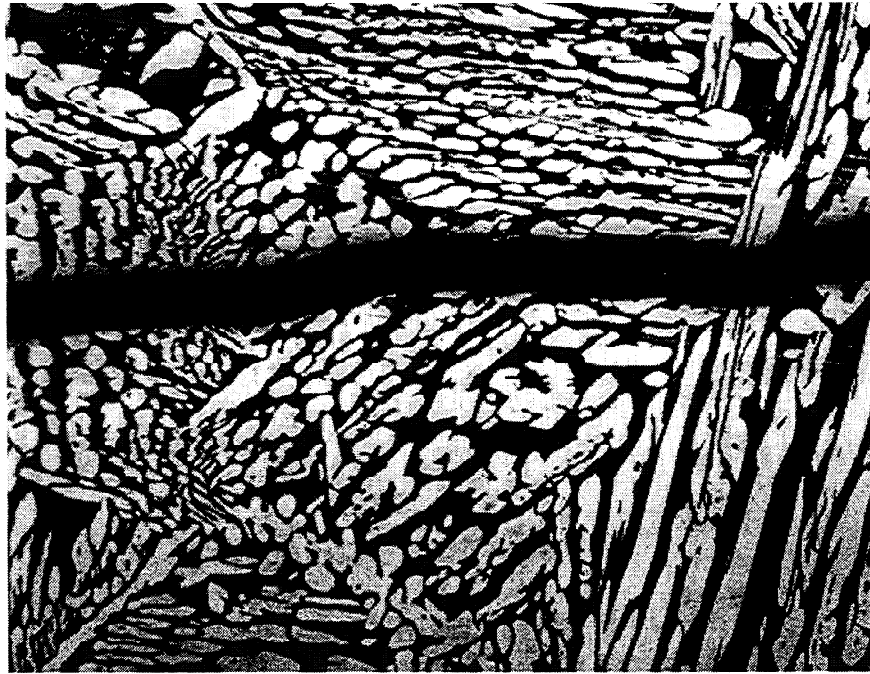
Figure 17. Fatigue crack path near middle of a VKA 378 CT-specimen tested in TAPPI-D + 5Cl⁻. This crack does not seem to favor any particular phase or interface in this duplex alloy.

The initial test was conducted in air to get a baseline for the performance of the material. The results are shown in Figures 10 and 11. The first figure shows a curve typical of fatigue crack growth. The second shows the same values plotted as a log-log plot. The results of the remaining tests are shown in Figures 12-16. Micrographs in Figures 17 and 18 show fatigue crack path at different areas of the specimen, representing different applied stress intensities. The fatigue crack path does not discriminate between the two phases of this duplex stainless steel nor does it favor interface between these phases.
